ASSET (BUS SHELTER) IMPROVEMENT EVALUATION STUDY

Final Report

June 2013

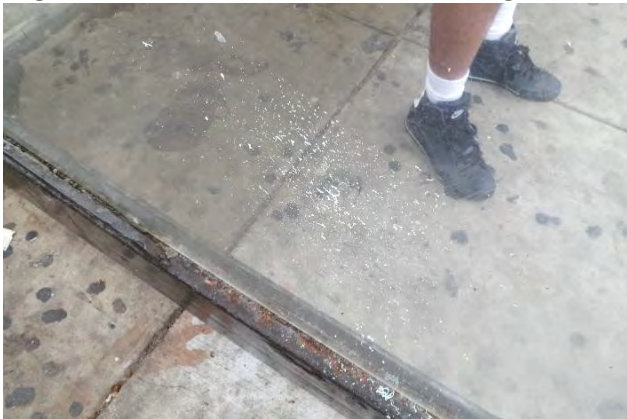
and panel condition, with most shelters showing rust and warped or broken panels. Shelters B and D are in the worst condition, with poor pads and significant rust on their frames. Shelter A is the only shelter without significant rust on its frame. Shelter E has damaged panels, including one popping out of the frame. Dome tops at the station are slightly below average, with fading and cracking present. **Figures 2 through 5** illustrate the different shelter conditions at the station, while **Figure 6** summarizes each shelter’s overall condition score.

Figure 2: Shelter B Rust on Frame, Damaged Panel

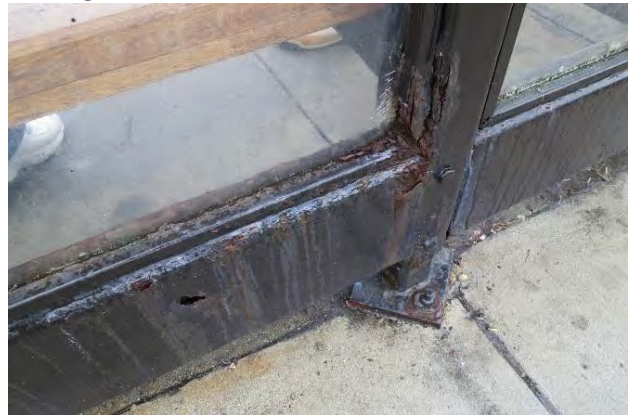
Figure 3: Shelter D Rust and Hole in Frame

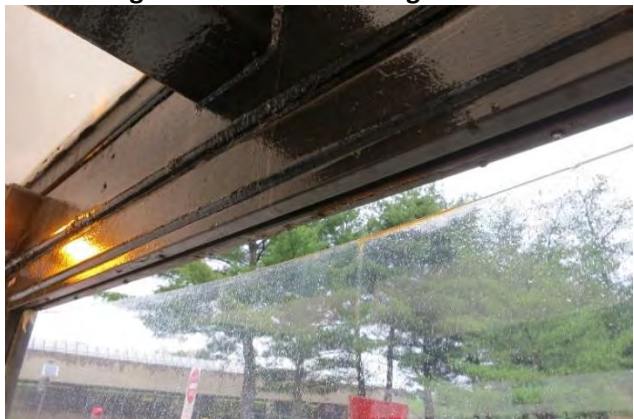
Figure 5: Shelter E Damaged Panel

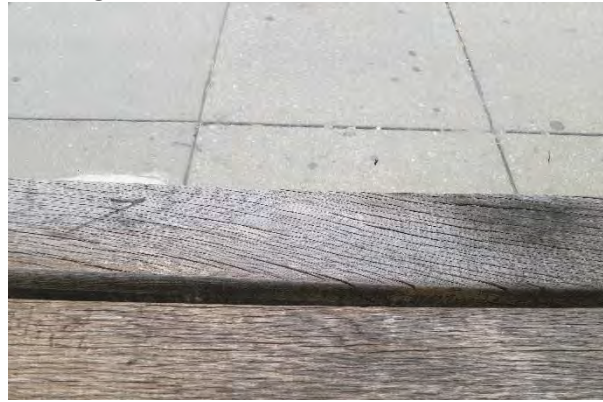
Figure 28: Weathered Bench, Shelter B

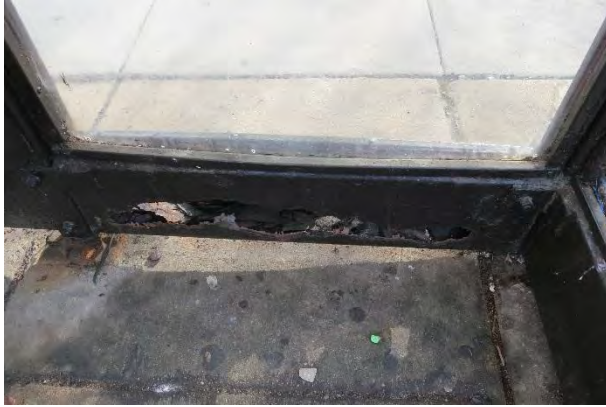
Overall, shelter conditions at the station are slightly below average, with a station condition score of 2.9. **Table 7** summarizes conditions for each individual shelter. The shelters, as a whole, scored the lowest in panel condition and dome top condition. Shelter A is in particularly bad condition, with two missing panels, a cracked dome top and a rusted frame with one leg missing entirely. Shelter D is also in poor condition, with a large hole in its frame. Shelter B and the Central Avenue shelter both have large cracks in their dome tops.

Figure 39: Hole in Frame, Shelter D

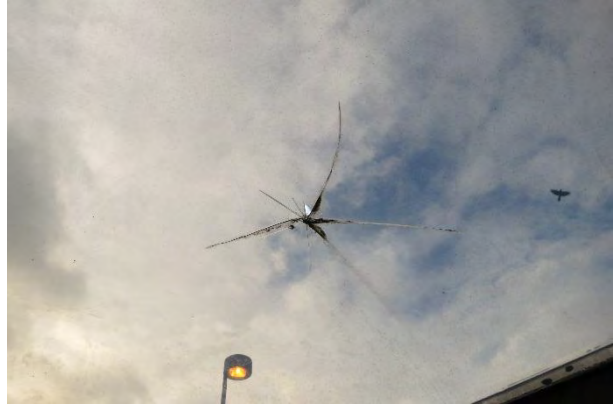
Figure 40: Crack in Dome Top, Shelter B

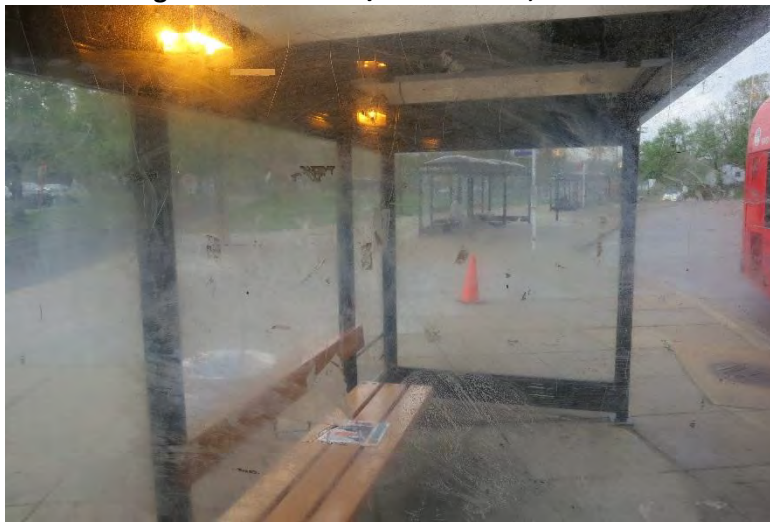
Rust on the frames was present on shelters A, B, D, and 2. Benches at the station were in the best condition of all the shelter elements and appeared to be recently replaced. Panels were generally smeared and faded at each shelter. **Figures 38 through 41** illustrate the different shelter conditions at the station, while **Figure 42** summarizes each shelter’s overall condition score.

Figure 41: Smearred/Faded Panel, Shelter C

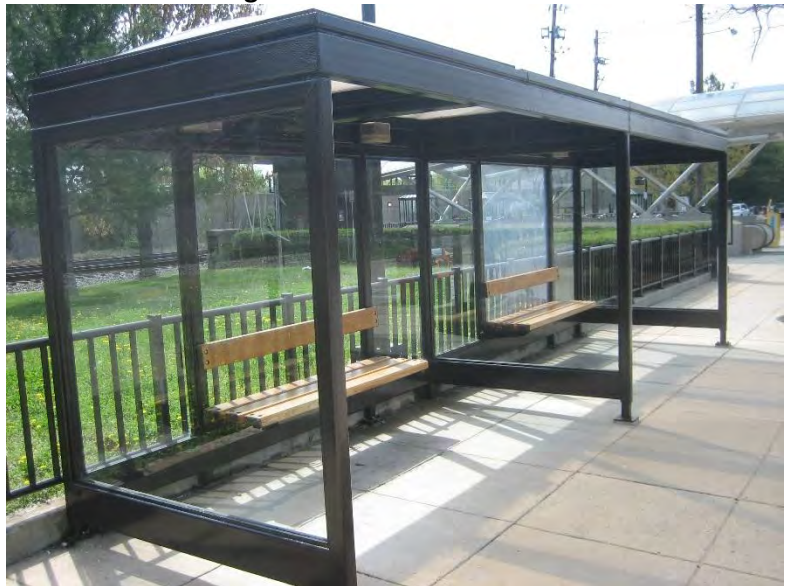
Figure 46: South Kiss & Ride

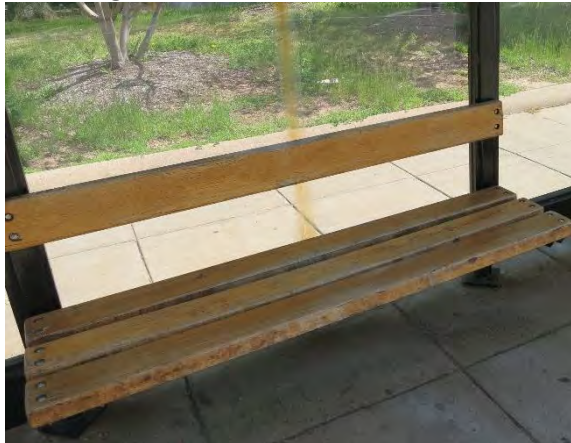
Figure 61: Worn Bench, Shelter B

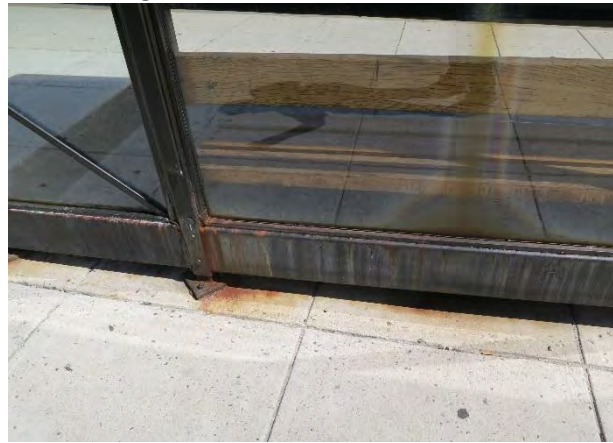
An average amount of rust was found on all the shelter frames with the exception of shelter A, which had little rust but had signs of past rusting on its pad and panels. Shelter C had significant rust on its frame.

Figure 62: Frame Rust, Shelter C

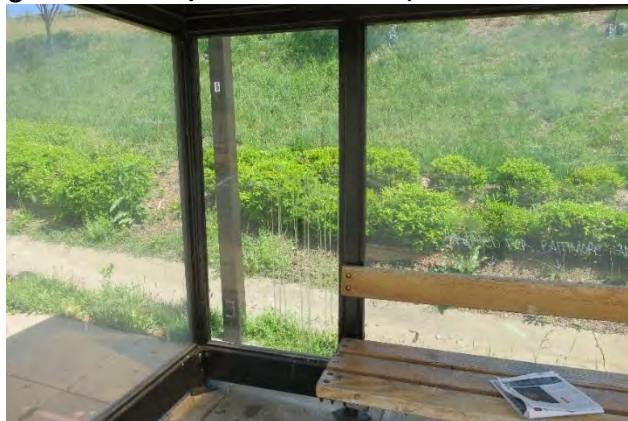
Figure 63: Faded/Scratched Panels, Kiss & Ride Shelter

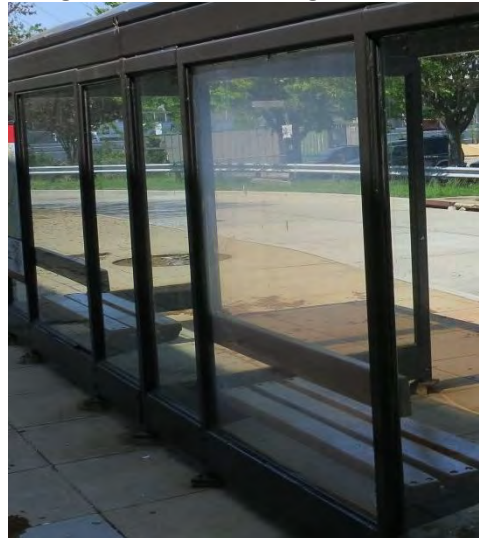
Figure 69: Panel Fading, Shelter D

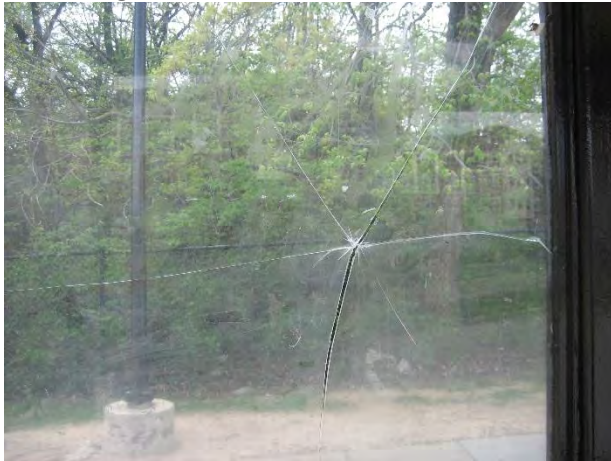
Figure 73: Cracked Panel, Shelter H

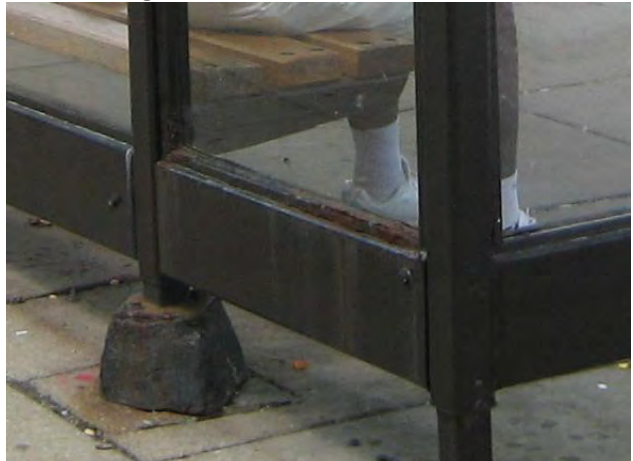
Figure 74: Frame Rust, Shelter E

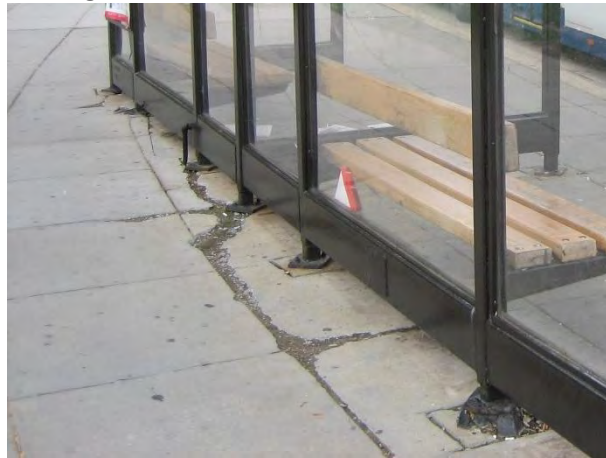
Figure 75: Poor Pad Condition, Shelter A

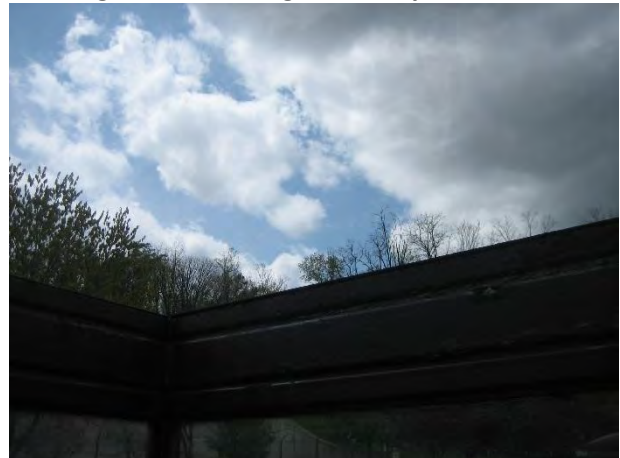
Figure 76: Missing Dome Top, Shelter C

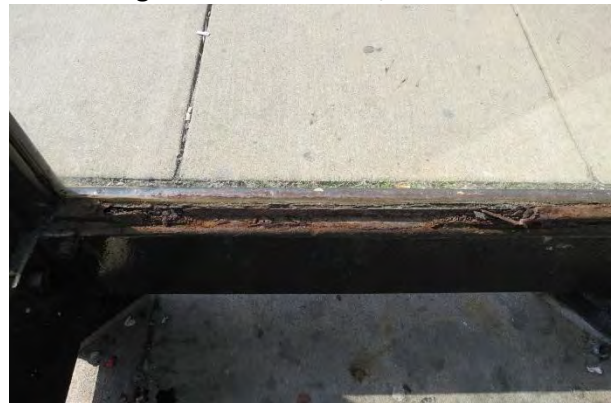
Figure 80: Frame Rust, Shelter F

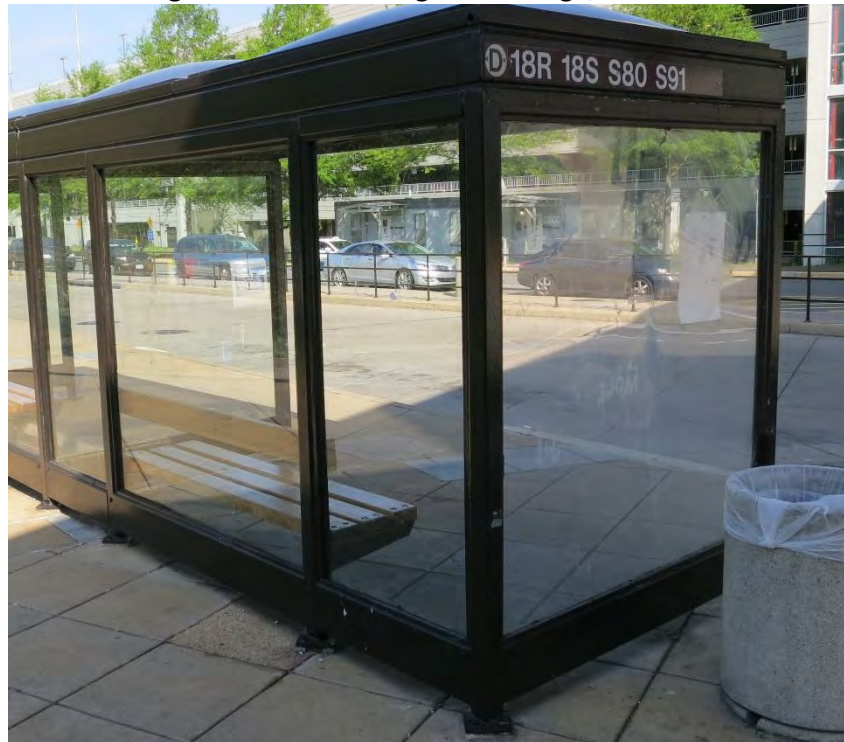
Figure 81: Panel Fading and Damage, Shelter D

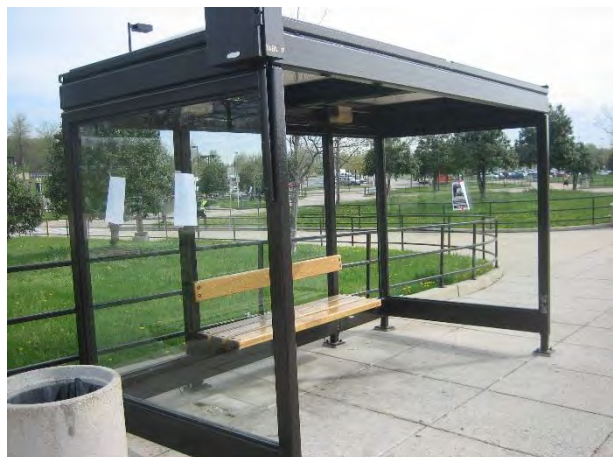
Figure 85: Excellent Shelter Condition, North Kiss & Ride

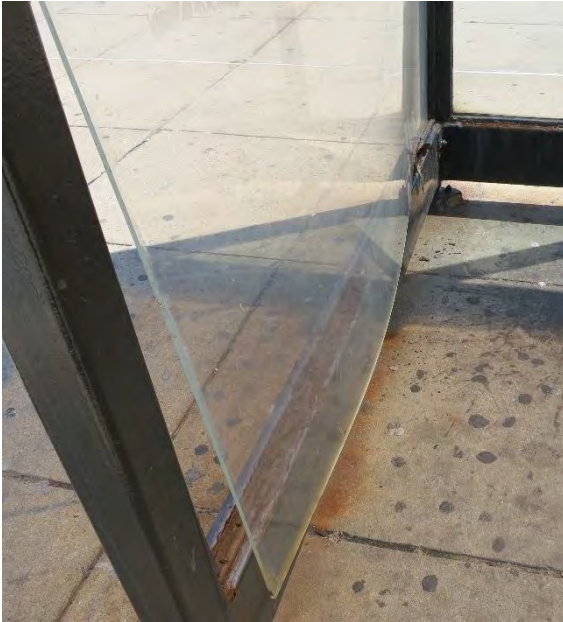
Figure 96: Damaged Panel, Shelter C South

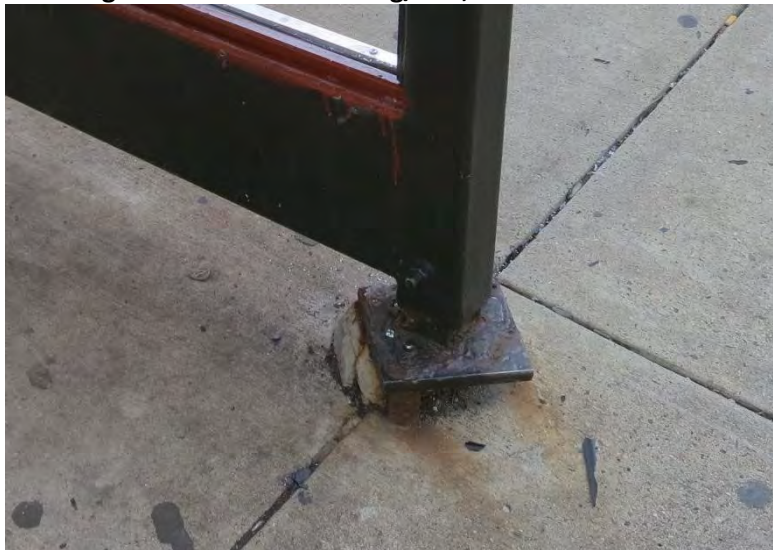
Figure 98: Cracked Footing/Pad, Kiss & Ride Shelter

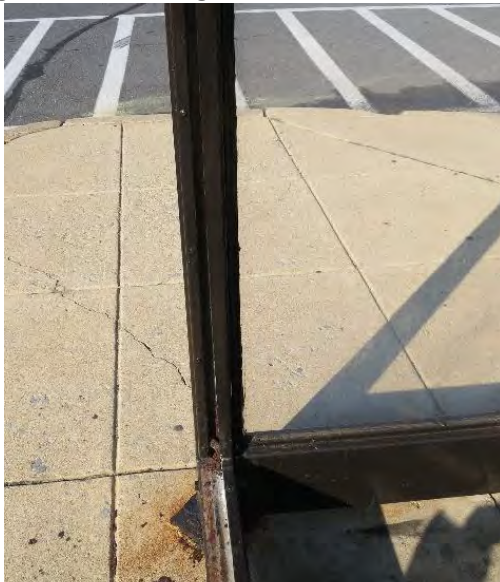
Overall, shelter conditions at the station are average, with a station condition score of 3.0. **Table 18** summarizes conditions for each individual shelter. The shelters as a whole scored the lowest in panel condition and pad condition. The Kiss-and-Ride shelter was missing a panel while shelter C had cracks in

Figure 101: Missing Panel, Kiss & Ride Shelter

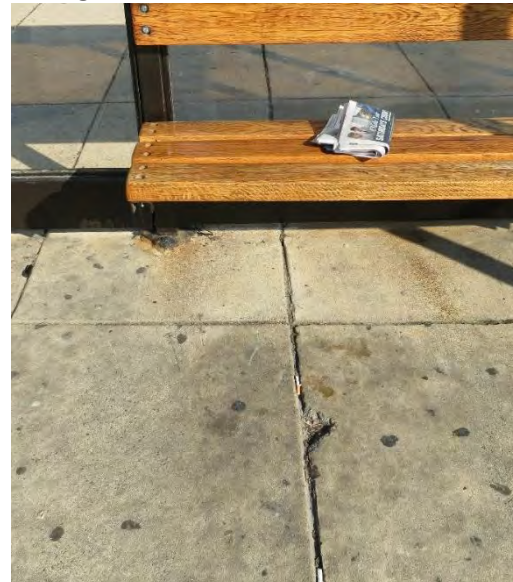
its pad and footings. Frame rust was present on all the shelters at the station, however it was not significant. Benches overall were in above average condition, as were dome tops.

Figure 102: Cracked Pad, Shelter C

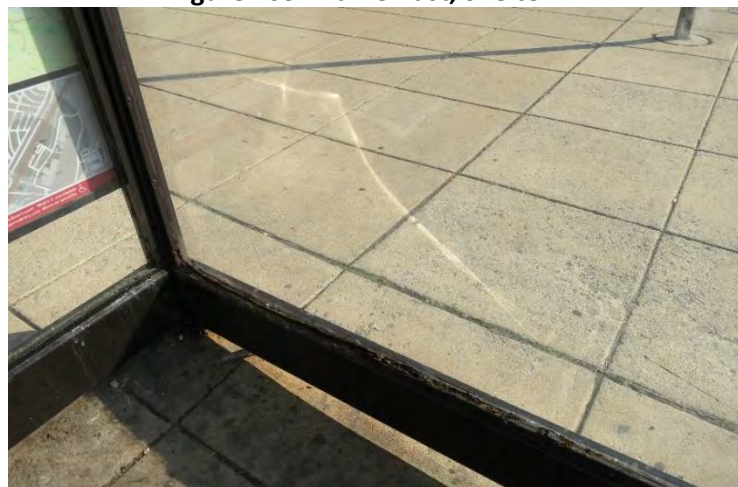
Figure 103: Frame Rust, Shelter D

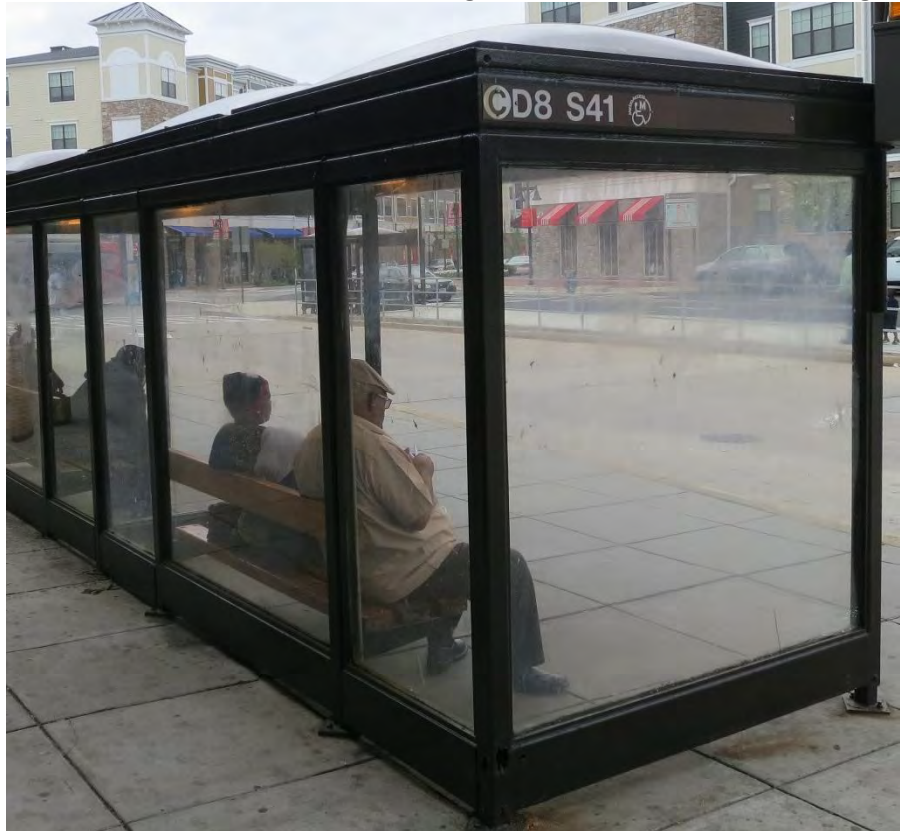
Overall, shelter conditions at the station are slightly below average, with a station condition score of 2.9. **Table 23** summarizes conditions for each individual shelter. The shelters as a whole scored the lowest in panel condition and dome top condition. Shelter C had a missing dome top while shelters A, D and E had damaged dome tops. Shelters C, D and F had damaged panels. Frames at the station all showed signs of rust with the exception of shelter F. Shelters C and E had a significant amount of rust on their frames, and shelter C even had a hole in its frame. Bench conditions were average at each shelter, while pad conditions were excellent, as the bus bays were recently reconstructed.

Figure 129: Poor Condition of Shelter C: Damaged Panel, Hole in Frame, Missing Dome Top

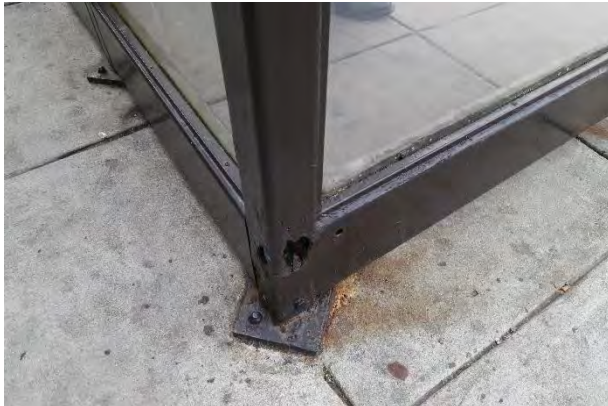
Figure 130: Hole in Frame, Shelter C

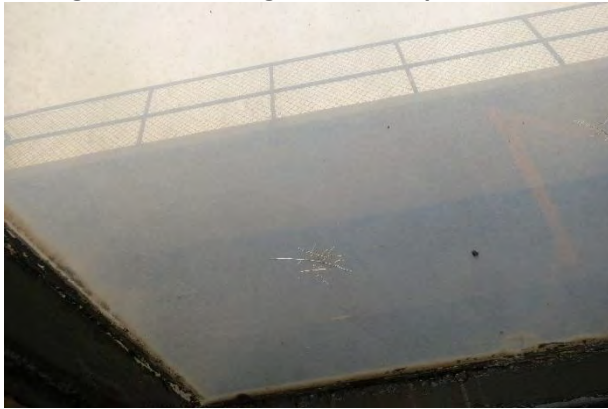
Figure 133: Damaged Panel, Shelter D

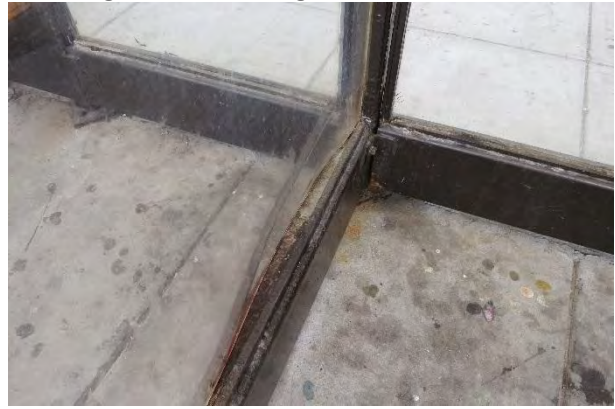
Figure 134: Good Pad Conditions Typical at Station

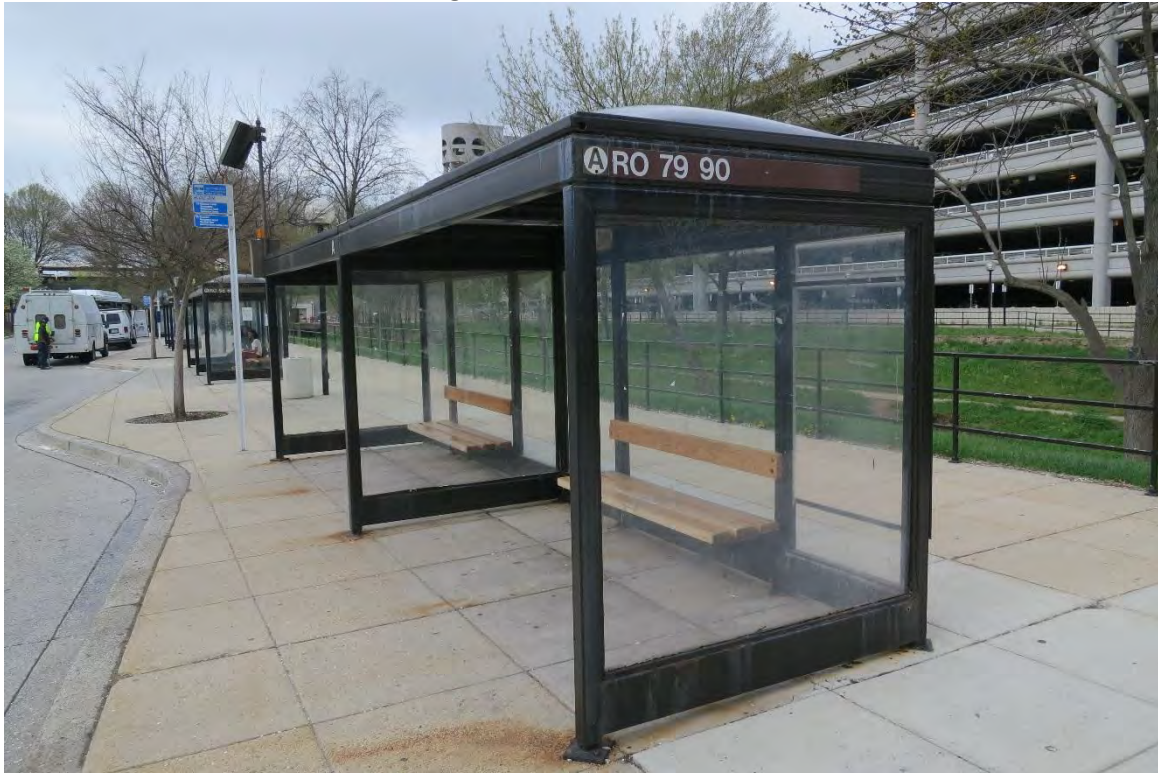
Figure 145: Shelter A East

Overall, shelter conditions at the Shady Grove station are average, with a station condition score of 3.1. **Table 25** summarizes conditions for each individual shelter. The shelters as a whole scored the poorest in frame condition and panel condition, with persistent rust and missing or damaged panels on several shelters. Shelters C West, A East and C East are in particularly bad condition, all receiving overall scores of 2. C West and C East both have holes in their frames, while A East has extensive rust and cracked/smearred panels.

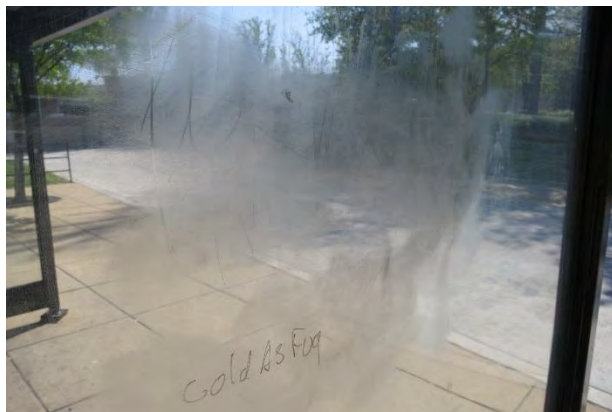
Figure 171: Faded/Smeared Panel, Shelter A

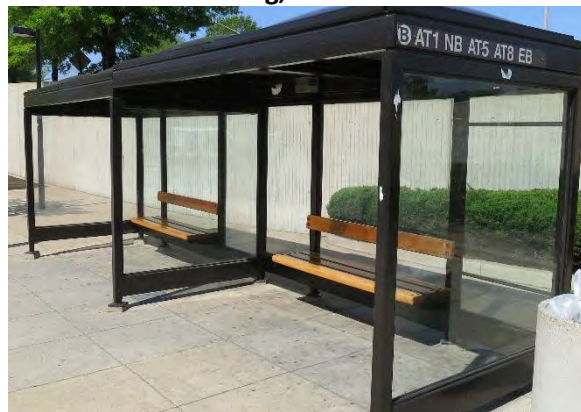
Figure 172: Good Frame Condition, Minor Paint Peeling, Shelter B

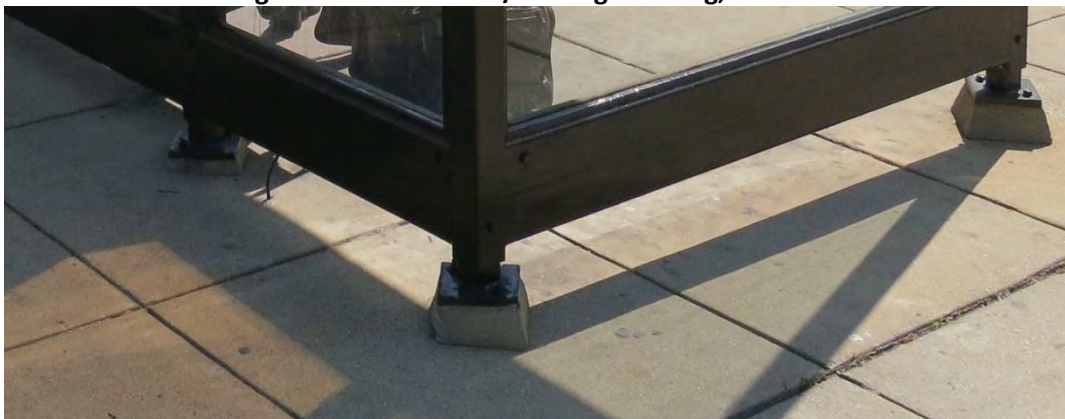
Overall, shelter conditions at this station are above average, with a station condition score of 3.9. Table 30 summarizes conditions for each individual shelter. The shelters as a whole scored the lowest in dome top conditions, though they were still above average overall. The dome tops on shelters A, B and C showed some signs of fading and wear. Frame conditions were good overall, with little to no signs of rust on any of the shelters and only some minor paint peeling on shelter B and the south Kiss-and-Ride shelter. Panel conditions were above average, with fading, scratching, and smearing present on shelters A, B (minor) and D only. Bench conditions were good, with minimal signs of wear overall. Pad conditions were also good, with minor cracking present only at shelter A and the north Kiss-and-Ride shelter.

Figure 173: Minor Pad/Footing Cracking, Shelter A

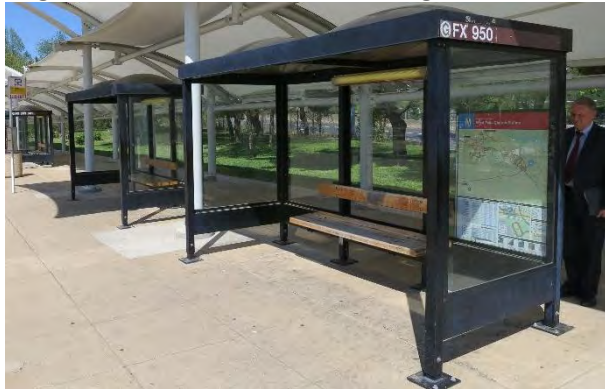
Overall, shelter conditions at the station are slightly above average, with a station condition score of 3.1. **Table 31** summarizes conditions for each individual shelter. The north side F through I shelters fared better overall than the rest of the shelters at the station and are a different design. The shelters as a whole scored the lowest in bench and frame condition. Benches showed a significant amount of wear at shelters G South, H South, G North, E North, and the Kiss-and-Ride shelter. Frames showed significant rusting at shelters A South, B South, D South, G South, H South, A North and C North, with D South also having a large hole in its frame. Dome tops were in average condition with the exception of shelter G South which had a large hole in its dome top. Panels were also in average condition, with fading and smearing present at all the shelters with the exception of the Kiss-and-Ride shelter, F North, G North, I North and C North. Shelters A South, F South and G South also had cracked panels. Pads were also in average condition, with some cracking present at shelters A South, C South, and D South.

Figure 176: Different Shelter Design of F-I North

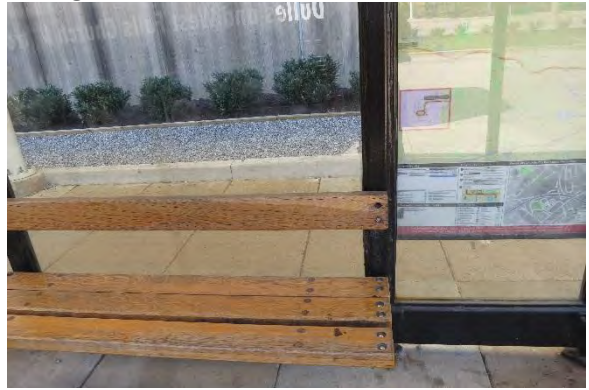
Figure 177: Worn Bench, Shelter E North

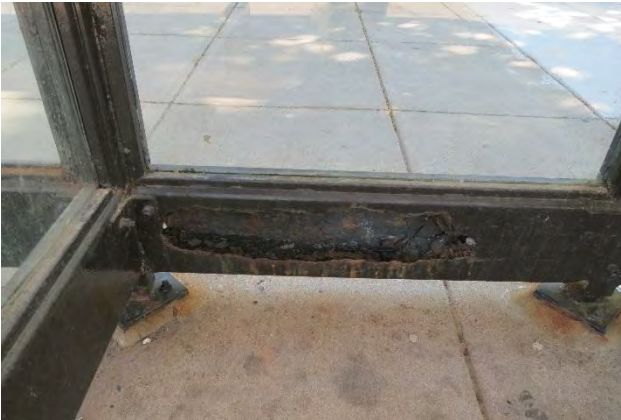
Figure 178: Large Hole in Frame, Shelter D South

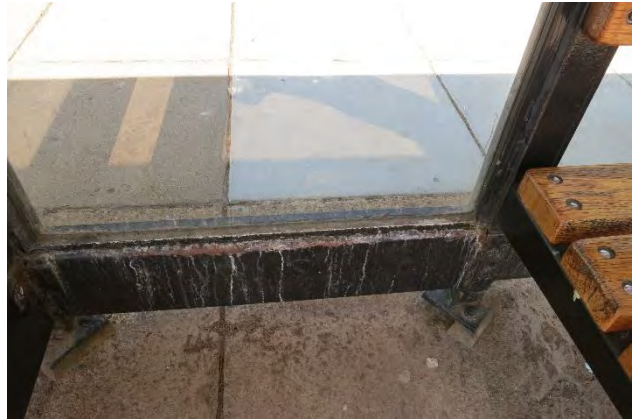
Figure 179: Frame Rust, E South

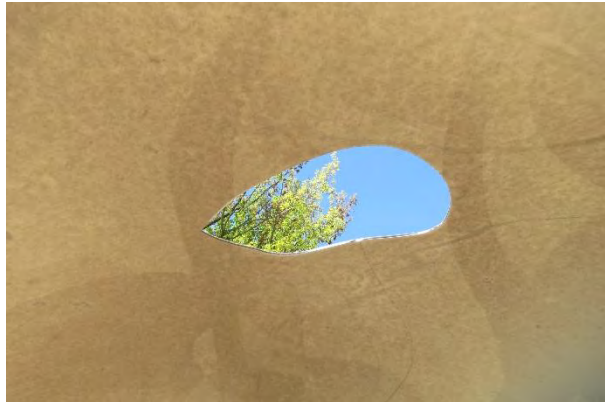
Figure 180: Hole in Dome Top, Shelter G South

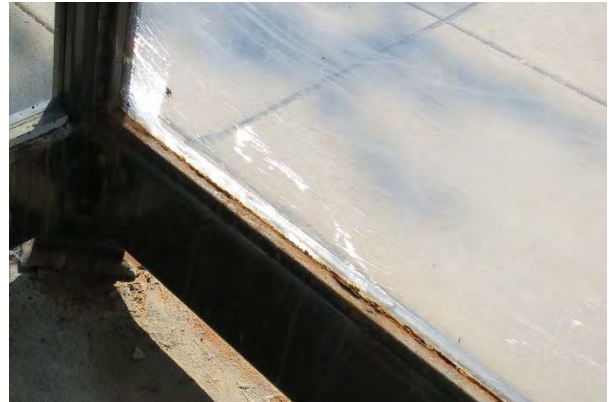
Figure 181: Damaged Panel, Shelter A South

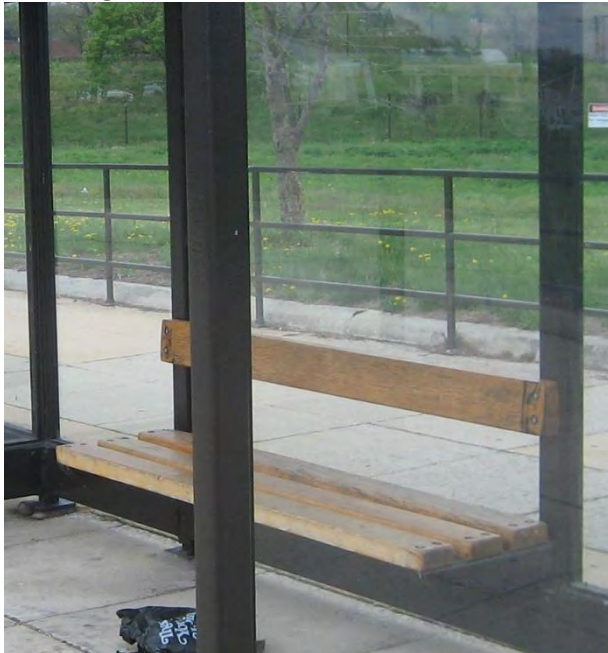
Figure 186: Wear on Bench, Shelter A

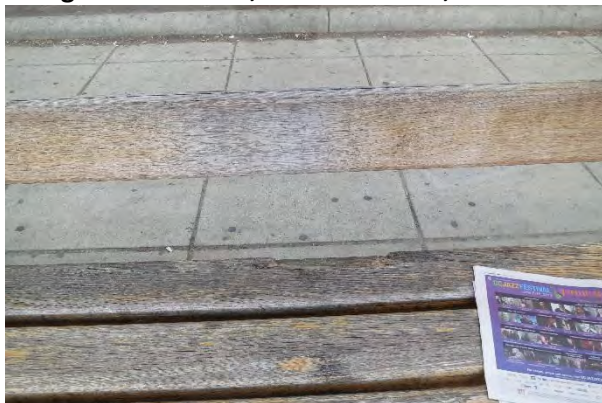
Overall, shelter conditions at the station are slightly above average, with a station condition score of 3.3. **Table 33** summarizes conditions for each individual shelter. The shelters as a whole scored the lowest in bench condition and panel condition. Benches at all the shelters showed wear, with those at shelters A, B, G, H, J, K, M and P in the worst condition. Panels generally had smearing or fading at every shelter with the exception of L, N and P. Panels at shelters A, D, E, F and K had other damage, with one panel missing at shelter A. Frame conditions were above average overall, with some rusting at shelters D, F, K, and M only. Dome tops pads were also in above average condition. Average amounts of cracking was present on the pads of shelters B, D, F, G, L, and M only.

Figure 191: Worn, Cracked Bench, Shelter B

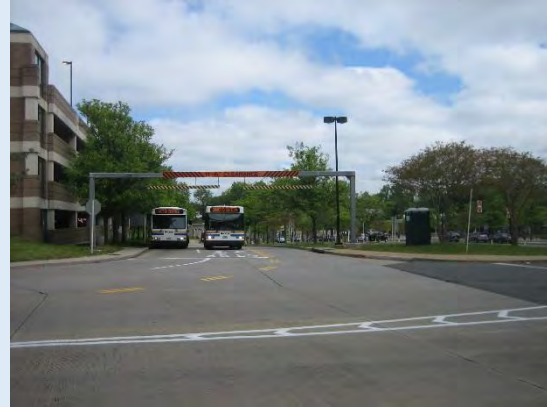
Southbound Approach

The driveway ends at the Kiss-and-Ride/Addison Road driveway with a stop line, stop lettered pavement markings and a stop sign. A directional sign to the Kiss-and-Ride and to Addison Road can also be found on the driveway approach. The driveway has an unmarked, exclusive right-turn lane and an improperly marked shared left-turn/right-turn lane. The left-turn/right-turn lane is marked as a thru/left-turn lane which is incorrect. Vehicles traveling southbound can either turn right to access Addison Road or turn

Right-Turn Only and stop pavement markings in the southbound right lane of the driveway at Kiss-and-Ride/Busway/Addison Road entrance driveway intersection.

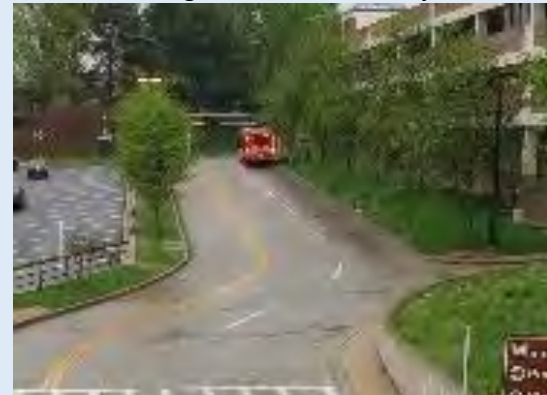
This driveway continues south to the Addison Road entrance driveway with two 12' wide southbound lanes and one 12' wide northbound lane. The right southbound travel lane is used as a layover area by many bus drivers. The driveway provides access to the Park-and-Ride garage to the west via a small slip ramp. There is signage at this point directing vehicles to the Park-and-Ride or the Kiss-and-Ride. The busway that serves the bus bays at the intersection flows into the driveway just north of the Park-and-Ride garage entrance. The busway has a stop line and two stop signs where it meets with the driveway, along with two “Do Not Enter” signs. There is an east-west crosswalk that traverses the driveway just south of the busway intersection. This crosswalk has corresponding curb ramps however they lack detectable warning panels. There are no warnings or traffic controls prior to this crosswalk in either direction. There are sidewalks on each side of the driveway between the busway and the Park-and-Ride garage entrance only. There is a sidewalk directly abutting the garage on its east side, however, it is far removed from the driveway itself and up-grade.

Southbound Right Lane Used as a Layover Lane

A formal bus layover area on the driveway between the Addison Road driveway and the Park-and-Ride garage entrance.

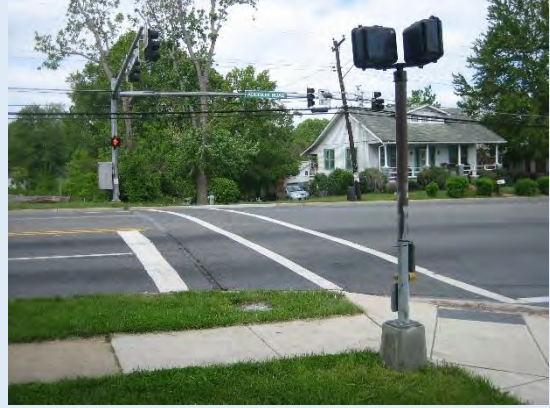
Addison Road/Station Entrance Driveway

This driveway forms a signalized T intersection with Addison Road. There is an overhead sign marking the driveway as the Metrorail station entrance. There are two thru travel lanes in each direction on Addison Road, along with an exclusive left-turn lane on Addison Road in the southbound direction. The driveway has an exclusive left-turn lane and an exclusive right-turn lane at the intersection. There is a north-south crosswalk that traverses the driveway with corresponding curb ramps and detectable warning panels. There is an east-west crosswalk that traverses the northbound approach of Addison road as well. This crosswalk has a curb ramp with a detectable warning panel on its east side, however, there is no curb ramp on its west side and no sidewalk on the west side of Addison Road. There are

Sidewalk along the west side of Addison Road with a curb ramp at the station entrance driveway crosswalk.

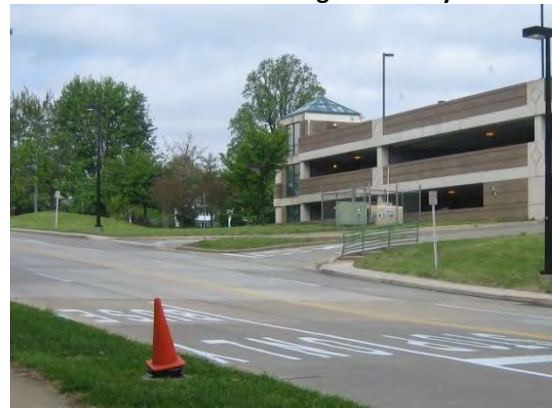
Park-and-Ride Garage Driveway

Stop signs at the Park-and-Ride garage driveway exit

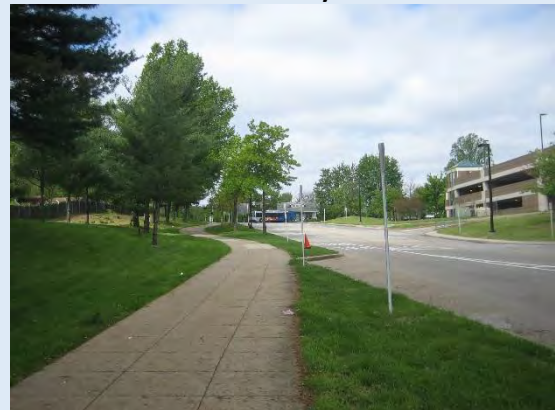
Crosswalk Traversing Central Ave Entrance Driveway

Fencing between the sidewalk and the driveway on its south side

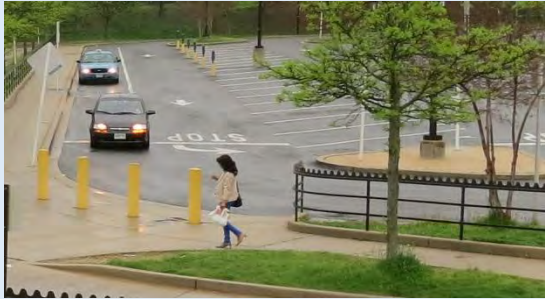
Kiss-and-Ride Lot Issues and Recommendations:	
Crosswalk traversing the east northbound travel lane, a curb ramp with detectable warning panel on the island there and a stop sign.	East Northbound Lane in Kiss-and-Ride

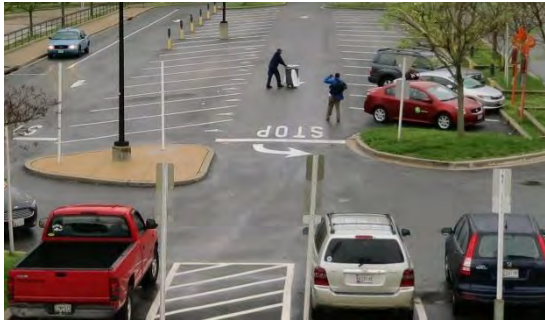
Replace yield sign with a stop sign at the center northbound travel lane terminus.	Center Northbound Lane in Kiss-and-Ride

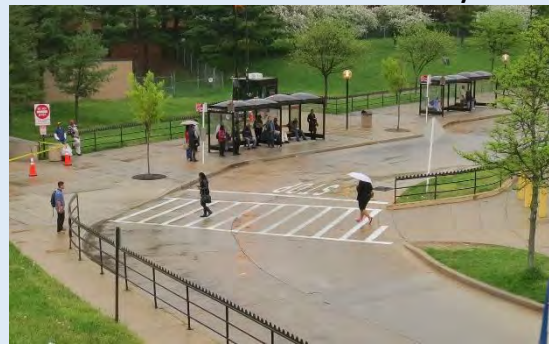
Crosswalk at North End of Busway

Stop signs prior to the crosswalk that traverses the busway at its north end.

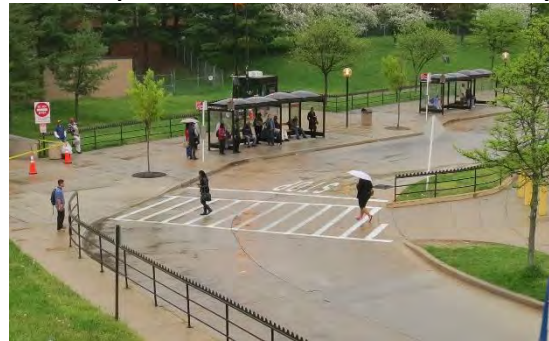
Curb Ramps at Crosswalk at North End of Busway

Detectable Warning Panels on the curb ramps at the crosswalk that traverses the busway at its north end.

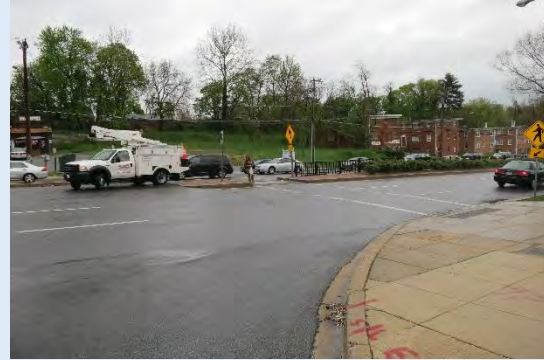
Central Avenue Crosswalk

“State Law Stop for Pedestrians in Crosswalk” sign and stop lines in each direction on Central Avenue at crosswalk.

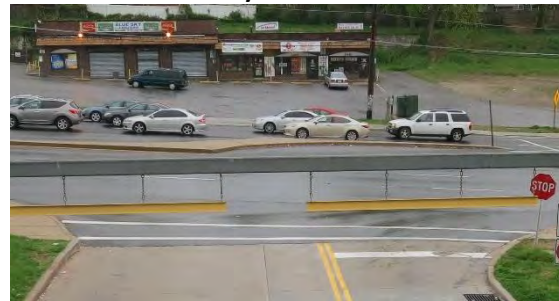
Left-Turn Bay on Central Avenue

Fencing along the left-turn bay on Central Avenue at the station entrance driveway

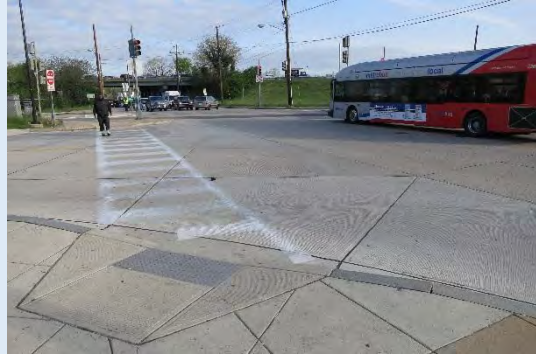
Stop Line Prior to Crosswalk at Howard Road.

Lack of Stop Line on Driveway Prior to Crosswalk

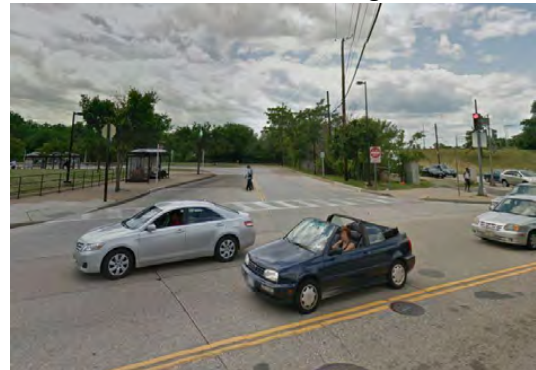
“Do Not Block Intersection” sign on Howard Road Westbound prior to the west entrance and “Do Not Block Intersection” pavement markings at the intersection.

Vehicles on Howard Road Blocking West Entrance

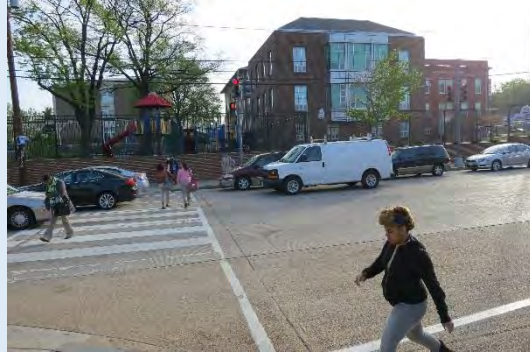
“Do Not Block Intersection” sign on Howard Road Westbound prior to the east entrance and “Do Not Block Intersection” pavement markings at the intersection.

Vehicles on Howard Road Blocking East Entrance

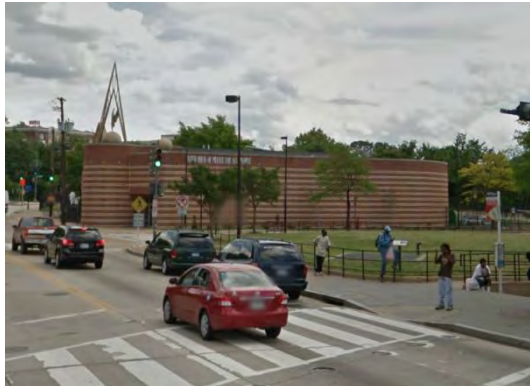
Howard Road Eastbound Prior to East Entrance

Additional “No Stopping or Standing” signs on Howard Road in the eastbound direction in front of the Metrorail station entrance (prior to the east entrance)

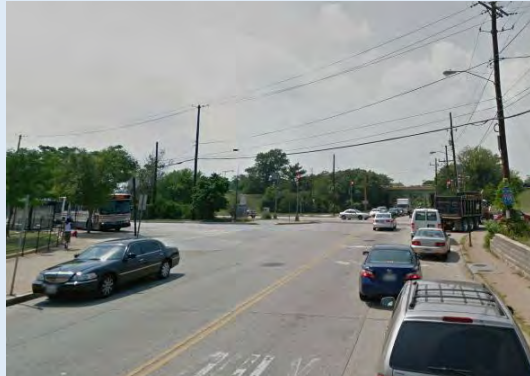
Howard Road East Entrance

“Buses Only” pavement markings on the east entrance.

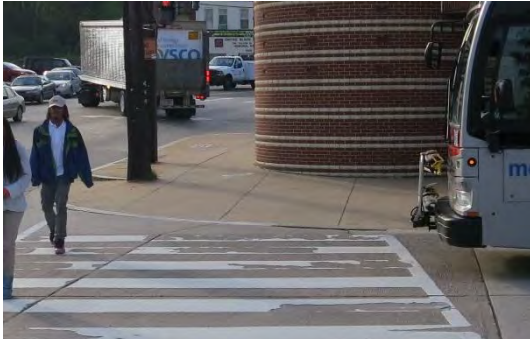
Curb Ramp On Southeast Corner of East Entrance

Detectable warning panel on the curb ramp at the southeast corner of the east entrance;

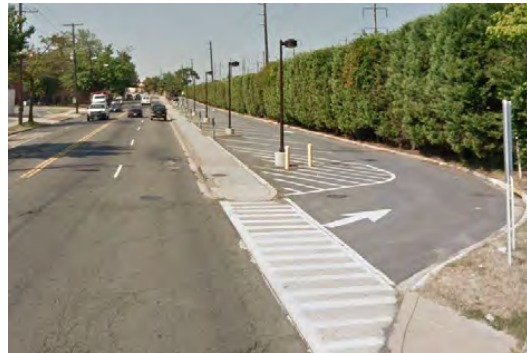
Kiss-and-Ride North Entrance

There is no signage identifying the Kiss-and-Ride parking area as such at the northern entrance or the center entrance in either direction on Minnesota Avenue. The Kiss-and-Ride area is under-utilized, primarily because it is not visible from the main Metrorail station entrance and does not allow people to re-circulate through it. Several people were observed dropping off on Minnesota Avenue directly in front of the station instead, despite the no stopping or standing signs located there, as pictured in **Figures 63 and 64**.

Signage indicating the two Kiss-and-Ride lot entrances on Minnesota Avenue in both directions.

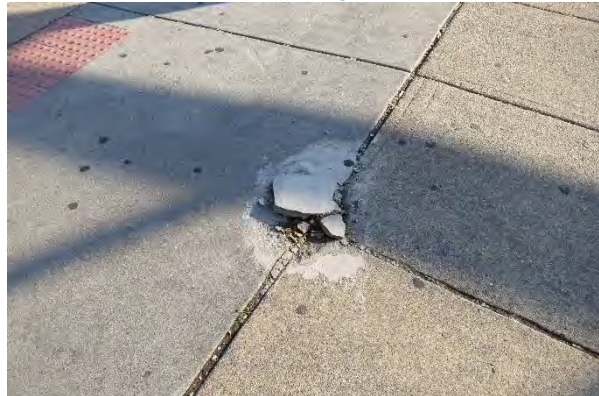
- The sidewalk on the east side of the busway crosswalk is uneven and has caused several patrons to trip
- Light maintenance is needed more regularly to keep bus bays safe at night

Figure 83: Uneven Sidewalk on East Side of Busway

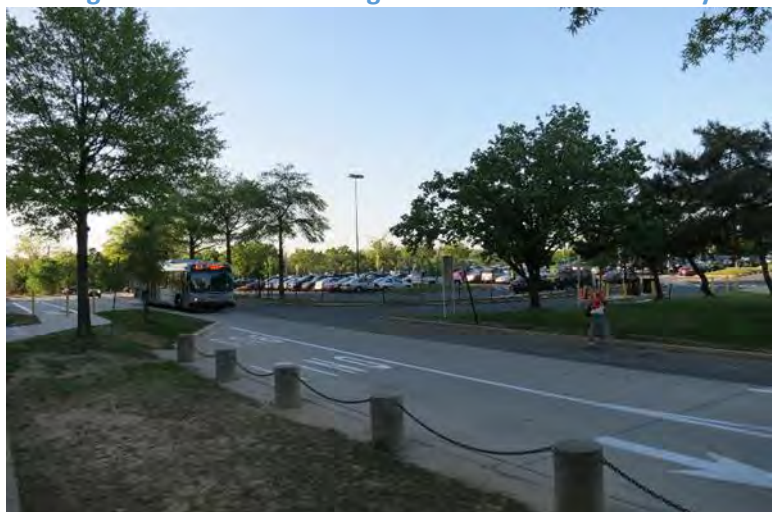
The driveway has a sidewalk along its north side that eventually leads directly into the Metrorail station entrance. It curves to the north to bypass a tree and grass area near the beginning of the busway, however, people were witnessed cutting through this grass area anyway. The north side sidewalk is joined by a sidewalk that extends from the garage stairwell entrance to the garage automobile entrance. There is a sidewalk on the south side of the driveway that curves around Metro Park-and-Ride Lot 2 to the south, separated from the driveway by a fence. No sidewalk exists along the driveway west of Lot 2 and people were witnessed walking in the driveway in this stretch as shown in **Figure 93**.

Figure 93: Patron Walking in Station Access Driveway

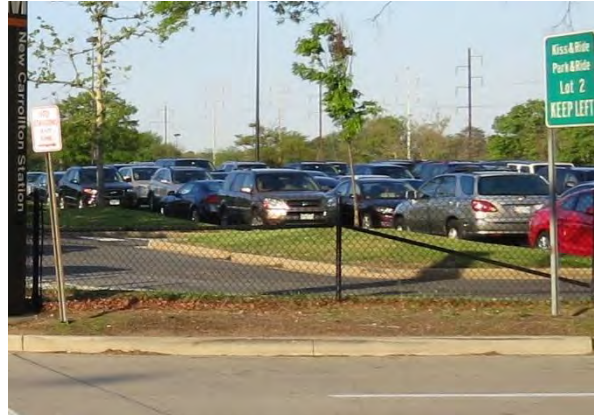
Figure 95: Kiss-and-Ride/Park-and-Ride Lot 2 Keep Left Sign

“Kiss-and-Ride Park-and-Ride Lot 2 Keep Left” sign at the beginning of the driveway that can be confusing to unfamiliar motorists who may interpret it to mean they need to be in the left lane in order to enter the Kiss-and-Ride. A second sign at the Lot 2 entrance directs motorists to turn left to enter Lot 2 or continue straight to enter the Kiss-and-Ride. A sign at the Kiss-and-Ride entrance detailing its

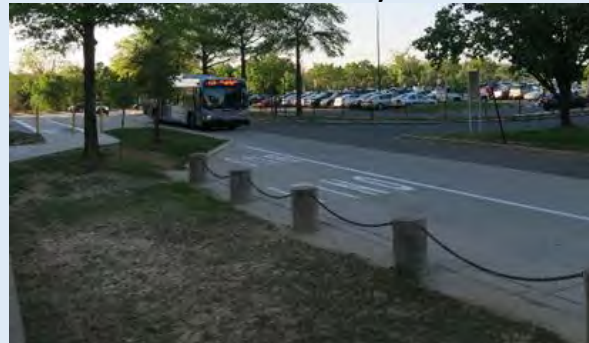
Grass Area Traversed by Patrons

Direct sidewalk along north side of driveway to Metrorail station entrance, removal of fence blocking grass area and replacement of low chain fence along busway entrance with a higher fence.

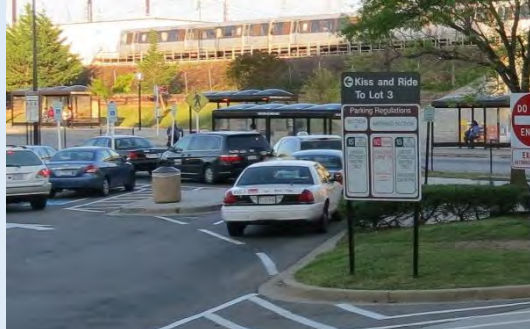
Taxicab Queuing Area

The Kiss-and-Ride entrance often backs up into the primary station access driveway as vehicles stop in the travel lanes to drop off or pick up station patrons. Additionally, the taxicab lane queue also backs up frequently and blocks the Kiss-and-Ride entrance completely.

Signage and enforcement to keep taxicab queue from extending into travel lanes.

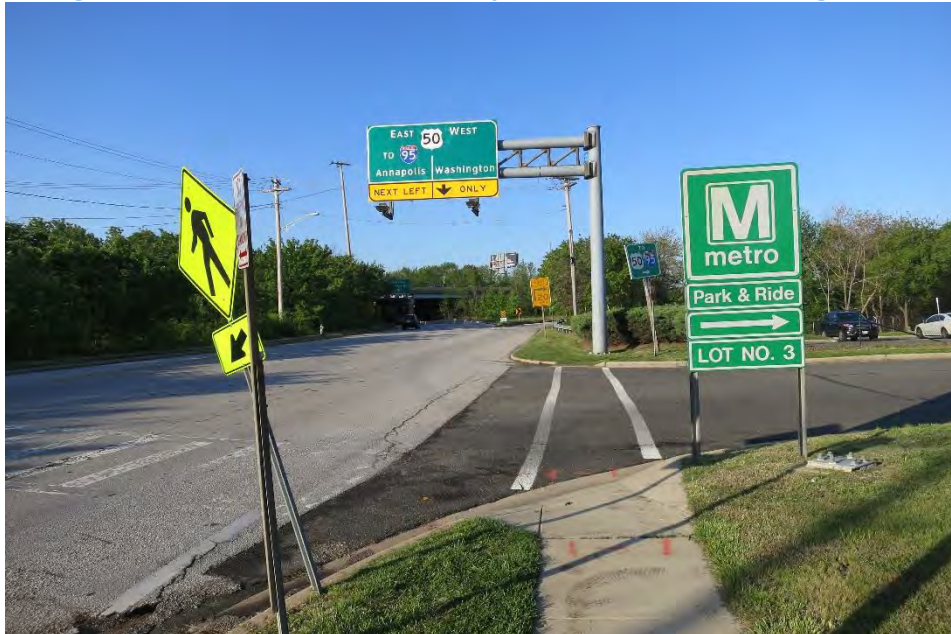
Figure 105: Station Lot 3/Garden City Drive Intersection Looking South

In the southbound direction on Garden City Drive, there are two pedestrian warning signs, a “State Law Stop for Pedestrians in Crosswalk Sign”, a “No Stopping or Standing” sign, a Metro Park-and-Ride Lot 3 sign and directional signs for US-50 and I-95. The driveway has a stop sign and directional signs to additional parking, US-50 and I-95. **Figures 105 and 106** illustrate this intersection.
