ASSET (BUS SHELTER) IMPROVEMENT EVALUATION STUDY

Final Report

June 2013

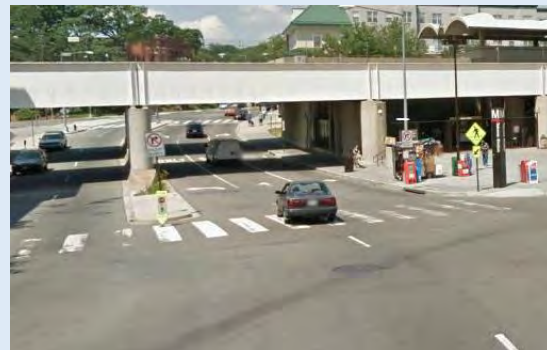
Cedar Street Metrorail Entrance

Drop-offs at the station typically occur on Cedar Street in the right-turn only lane directly in front of the station, despite the “No Stopping or Standing” signs on Cedar Street and the right-turn only pavement markings. No enforcement of these signs was observed. The Kiss-and-Ride was only utilized by those waiting to pick up patrons for a longer time period.

Enforcement of “No Stopping/No Standing” signs on Cedar Street in front of Metrorail station entrance.

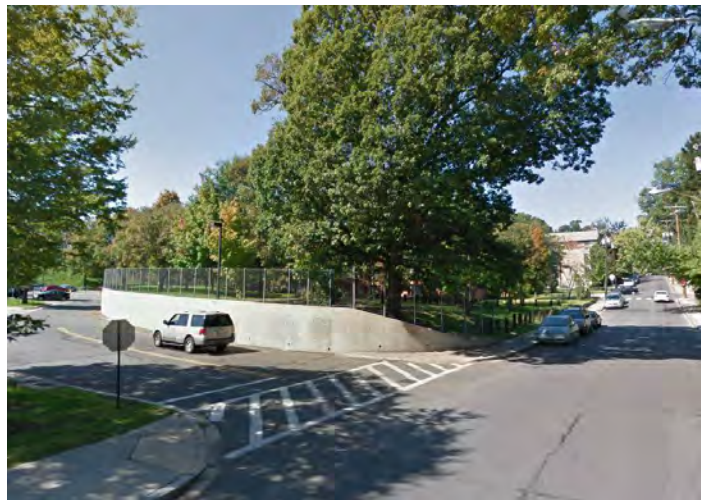
Figure 119: Entrance to Kiss-And-Ride Lot from Eastern Avenue Northbound

The station's Kiss-and-Ride lot entrance is on Eastern Avenue to the north and west of the busway. The lot is not clearly marked from the street and has no entrance signage. There is a stop sign on the lot driveway approach to Eastern Avenue along with a crosswalk and apex curb ramps across it. The curb ramps do not have detectable warning panels though are otherwise ADA-compliant. The lot itself has a crosswalk from the handicapped parking spaces to the sidewalk along the western side of the lot. **Figure 119** pictures the entrance to this lot.

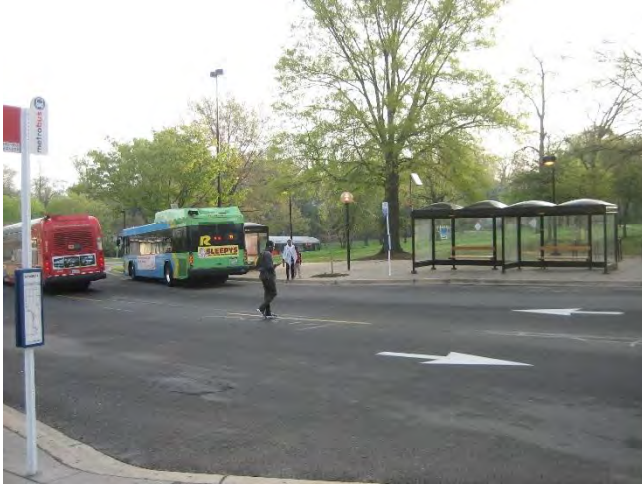
Figure 121: Jaywalking across Busway to Station

There are two major pedestrian movements accessing the station: towards the main Metrorail station entrance and towards the station elevator tunnel. As expected, pedestrians use the shortest path possible to access both the elevators and main station entrance. This results in a large amount of hazardous jaywalking across the busway, whether it is from a bus dropping off in bus bays G through J, or walking trips from the neighborhoods to the east of the station through the park adjacent to it. **Figure 120** illustrates these movements. People accessing the elevator tunnel from these locations also jaywalk across the busway and then cut across the grass area behind bus bay D, resulting in a visible desire line path to the tunnel. People accessing the station from Cedar Street generally use the sidewalks along the roadway and the crosswalks at the busway intersection. **Figures 121 through 124** illustrate pedestrian movements to the station.

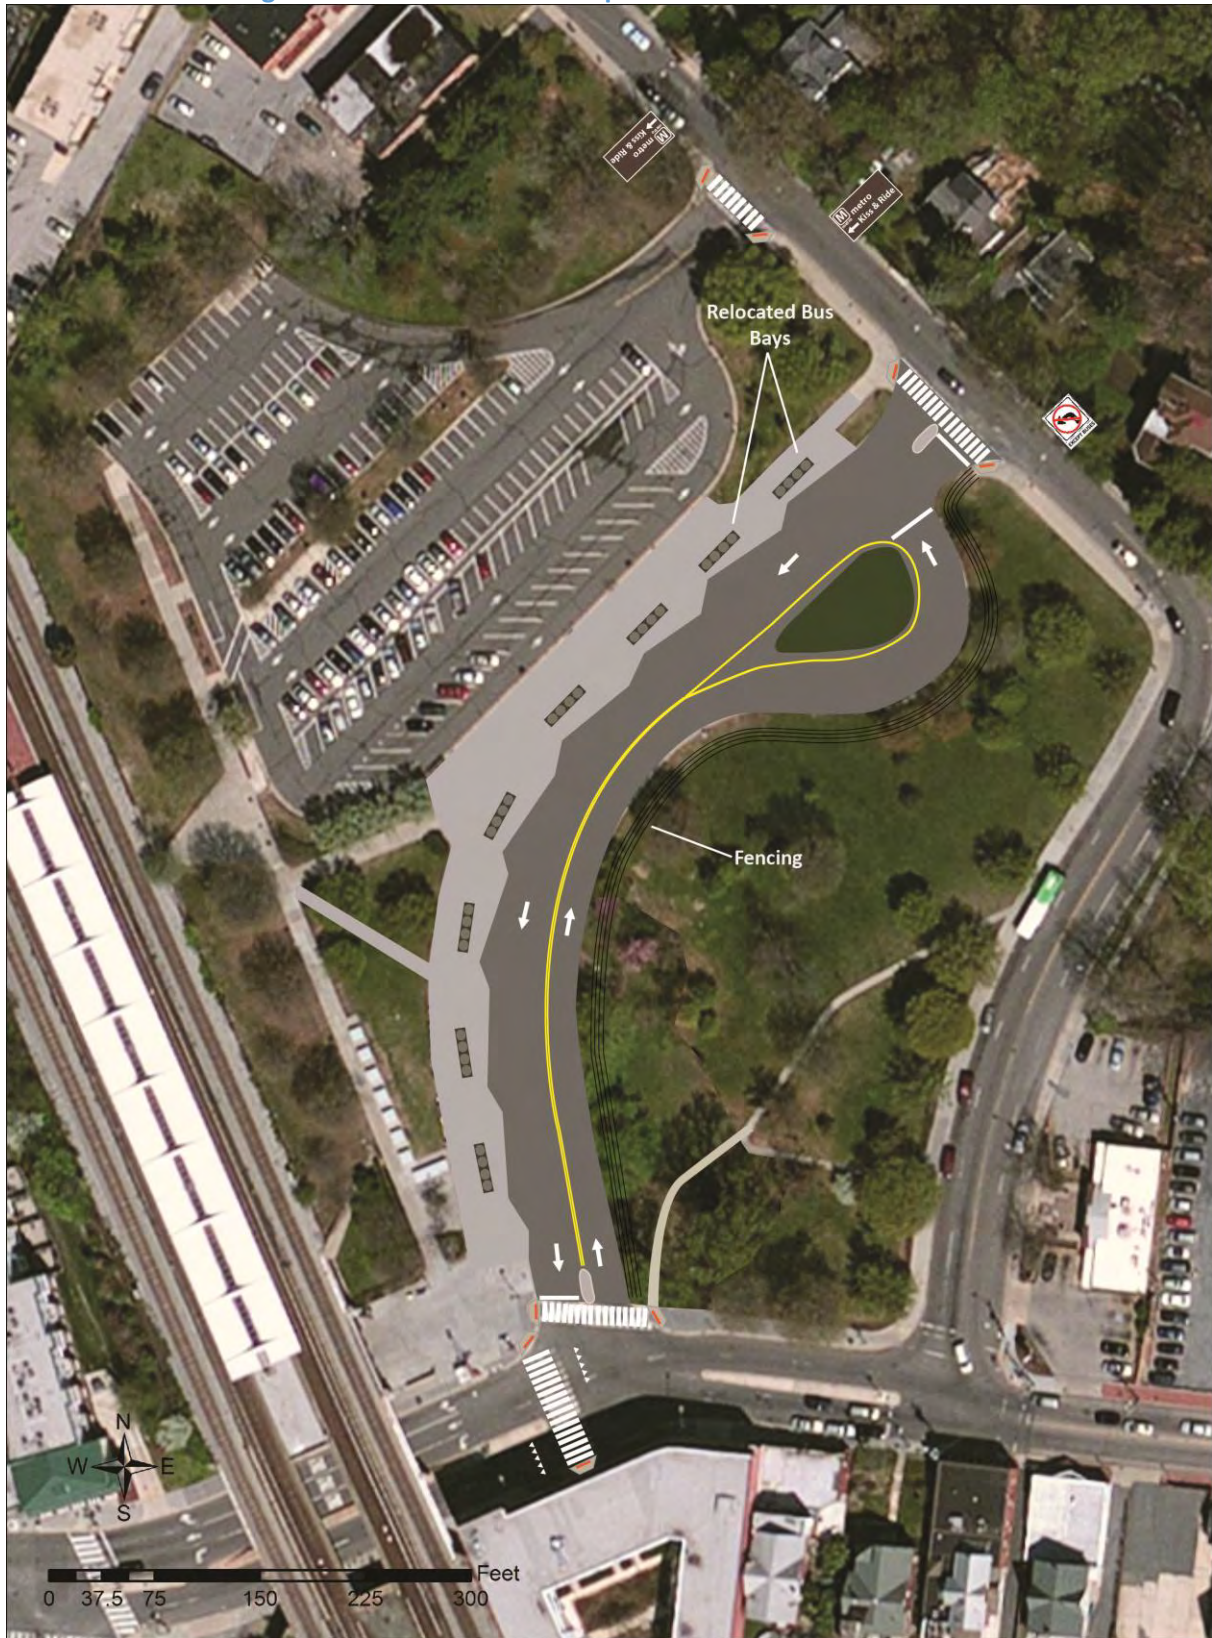
Figure 125: Recommended improvements at Takoma Station

Discussion with the Takoma station manager confirmed the prevalence of jaywalking at the station, though it was noted that “near misses” and crashes between buses and pedestrians were non-existent or at least extremely rare. The need for a few “Pedestrians Use Crosswalk” signs between the G-J bus bays and the A-F busways was mentioned, along with some enforcement. When it came to internal pedestrian circulation at the station, the station manager declined the need for additional signage directing people to buses and the elevator, stating that she thought this was within the job duties of the

Table 6: Summary of Recommendations at the Takoma Station	
Infrastructure	On or Off Station
<p>Reconfigure the busway and bus bay layout to guide people to cross safely at the crosswalk at the Cedar Street intersection. There are two potential options for this improvement:</p> <ul style="list-style-type: none"> Option 1: Widen the busway from its current 45' width to a 65' width in order to construct a median and fencing down the center. Widening would allow for enough room for buses to pass one another according to WMATA's Station Site and Access Planning Manual, adopted in 2008 Option 2: Install fencing along the east side of the busway and relocate bus bays G and H to the western side of the busway and eliminate bus bay J completely. This would allow for a 15' northbound thru bus lane 30' wide (at their narrowest points) sawtooth bus bays. Currently there is approximately 150' between Bus Bay A and Eastern Avenue, which would allow for two additional 70' long bus bays to be constructed. Buses would use the turnaround for all trips into the station from Cedar Street, with the exception of the (new) northernmost bus bay. To access the northernmost bus bay, buses would have to enter from Eastern Avenue as the turnaround is too far north to allow a bus to use it. Buses that previously used Bus Bay J (Ride-On Routes 16, 18 and 25) could use Bus Bay A instead, which is currently unused 	On

Figure 125 illustrates these recommendations.
